**RE: Indoor Air Quality (IAQ) and Mold Assessment Services
Prince George's County Public Schools – Doswell E. Brooks Elementary School
1301 Brooke Road, Capitol Heights, Maryland 20743
Contract No.: IFB 022-19: Indoor Air Quality Services at Various Locations
Tidewater Project No.: 5419-038**

Tidewater, Inc. (Tidewater) is pleased to present this final report regarding the results of the Indoor Air Quality (IAQ) and Mold Assessment Services conducted by Tidewater at Doswell E. Brooks Elementary School located at 1301 Brooke Road in Capitol Heights, Maryland. Tidewater's Project Manager and Certified Industrial Hygienist, Mr. Skanda Abeyesekere MS, CIH, CSP, CHMM conducted these services on December 3, 2020. Re-sampling of areas with elevated mold concentrations were conducted on February 23, March 2 and March 9, 2021.

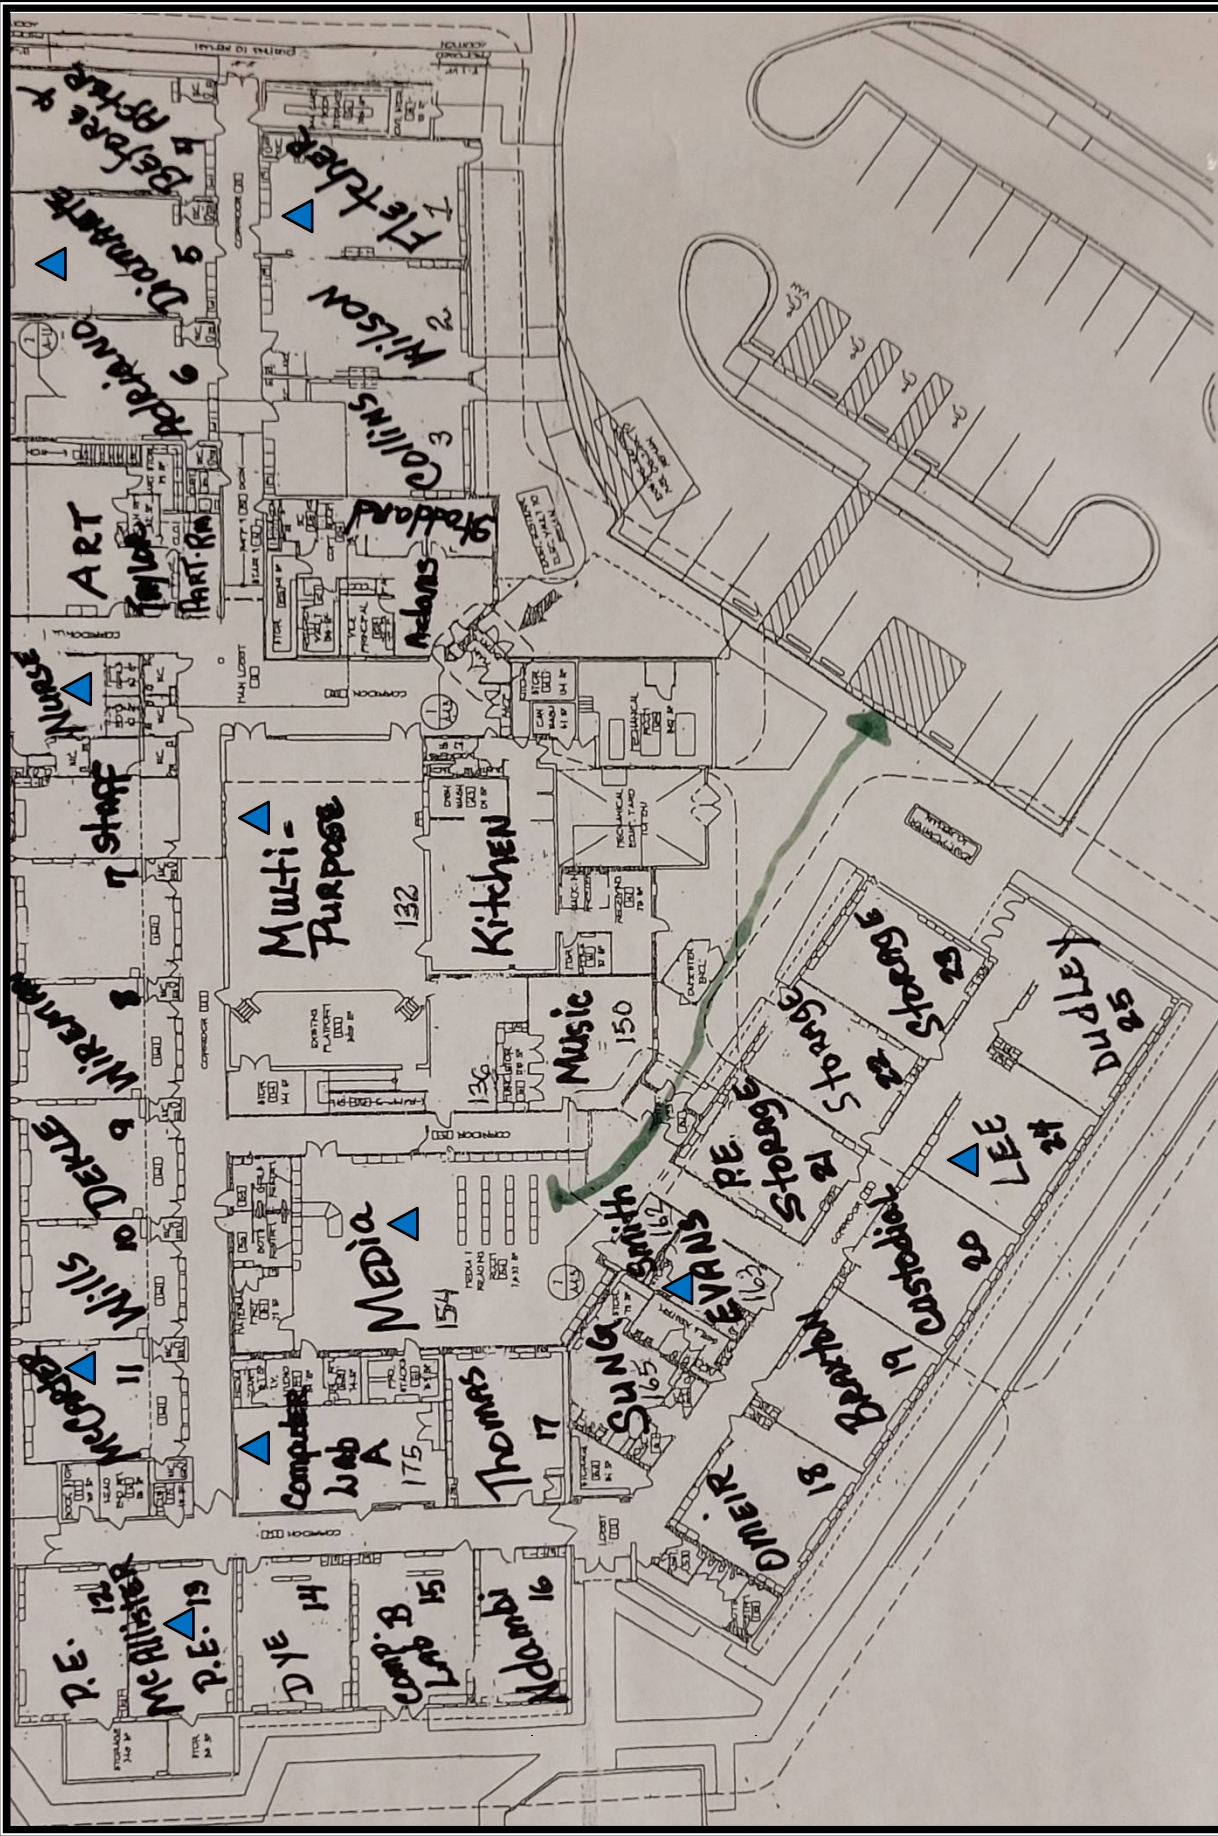
Attachment C
 Doswell E. Brooks Elementary School
 Floor Plan with Sampling Locations

FLOOR PLAN WITH SAMPLING LOCATIONS
